R.M.S. Carpathia

A Brief History
and Suggested Dive Plan

June 2004

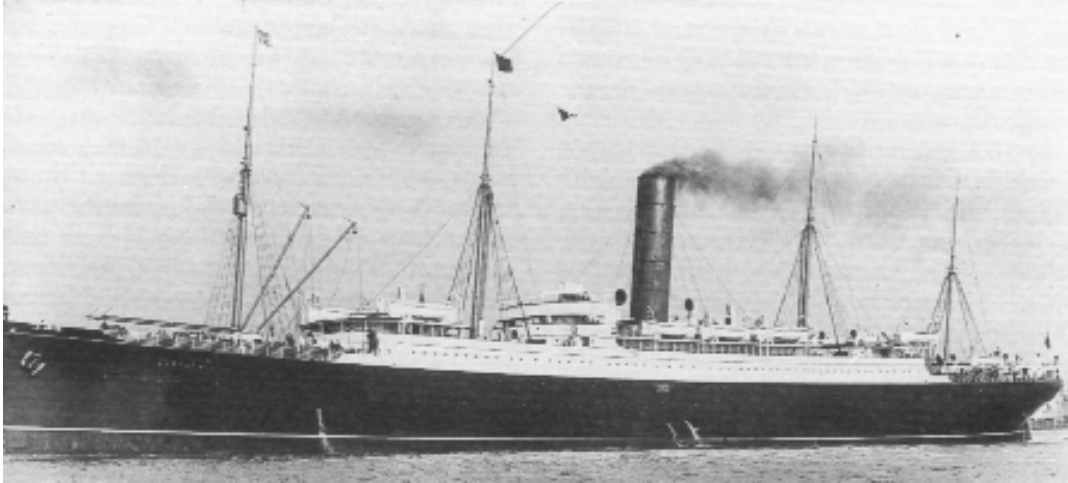
Above: The Cunard Steamer RMS *Carpathia*. The ship was essentially a smaller version of the S.S. *Ivernia*, and was designed for the Cunard Line's emigrant service between New York and the Mediterranean.

The Twin Screw Cunard steamship *Carpathia* was laid down at the Wallsend-on-Tyne works of C & S Swan, Hunter in 1901. She was launched on 6th August 1902 and, after fitting out, registered 13,555 gross tons. She was 558 feet in length with a breadth of 64 feet 6 inches and a depth 40 feet. Her two quadruple-expansion engines, built by the Wallsend Slipway Company, gave her a maximum registered speed of sixteen knots, although her service speed was usually closer to fourteen.

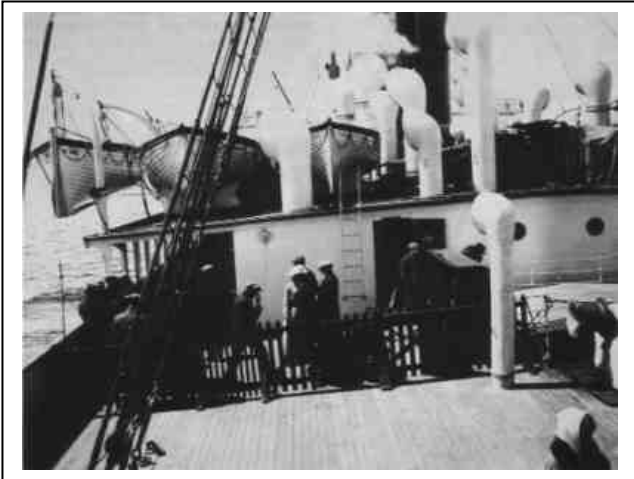
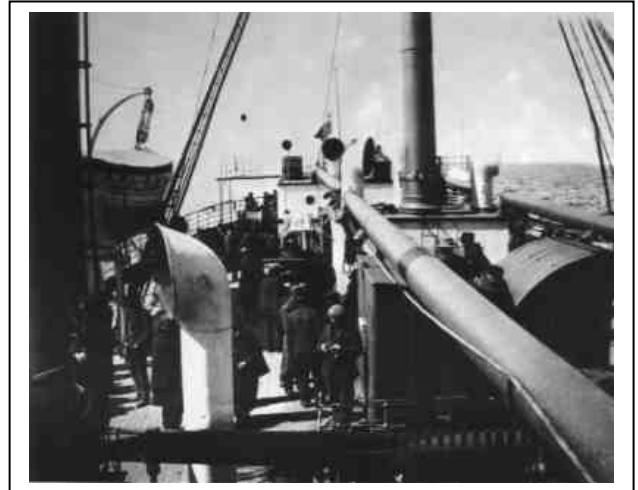
Above: Two views from *Carpathia's* aft shade deck above the passengers' smoke room, both taken after the *Titanic's* lifeboats had been recovered. The first picture was taken from the port side looking forward towards the ship's main boat deck, while the second picture (looking aft) was taken from the starboard side but slightly further aft. Note that in the second picture, *Carpathia's* flag is at half-mast.

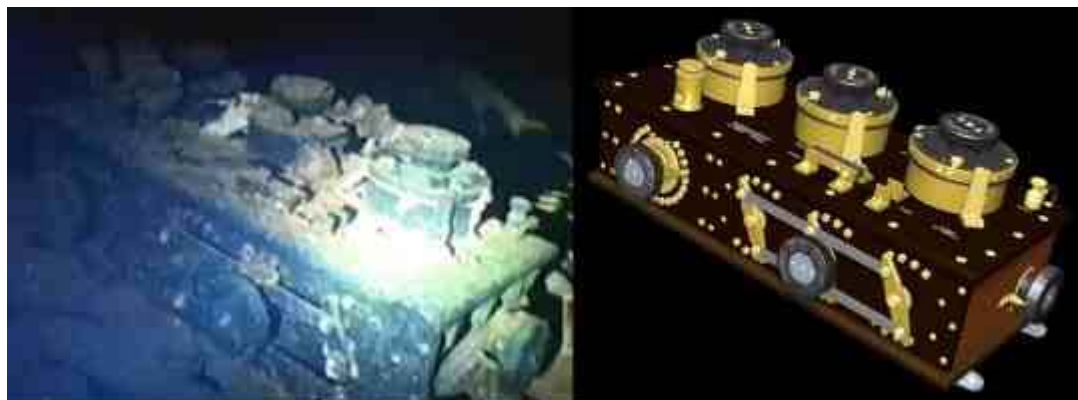
person who completed this CGI recreation of *Britannic's* Mk V Marconi installation, based on the 2003 video that you supplied.

In any event, all the books that I have read seem to suggest that *Carpathia's* Marconi room was located directly above the aft smoke room, which I have marked (in yellow) on the supplied deck plans. *NB:* Parks Stephenson in America will be fascinated to know how it is laid out, etc. so as much detail in this area will be useful – he was the
